2022 – “State of the Streets” City of Harvard, IL

Sadaf Khosravifar, PhD, PE
IMS Infrastructure Management Services, LP
Date: 8/25/2022 (Virtual Meeting)

Pavement Condition Survey

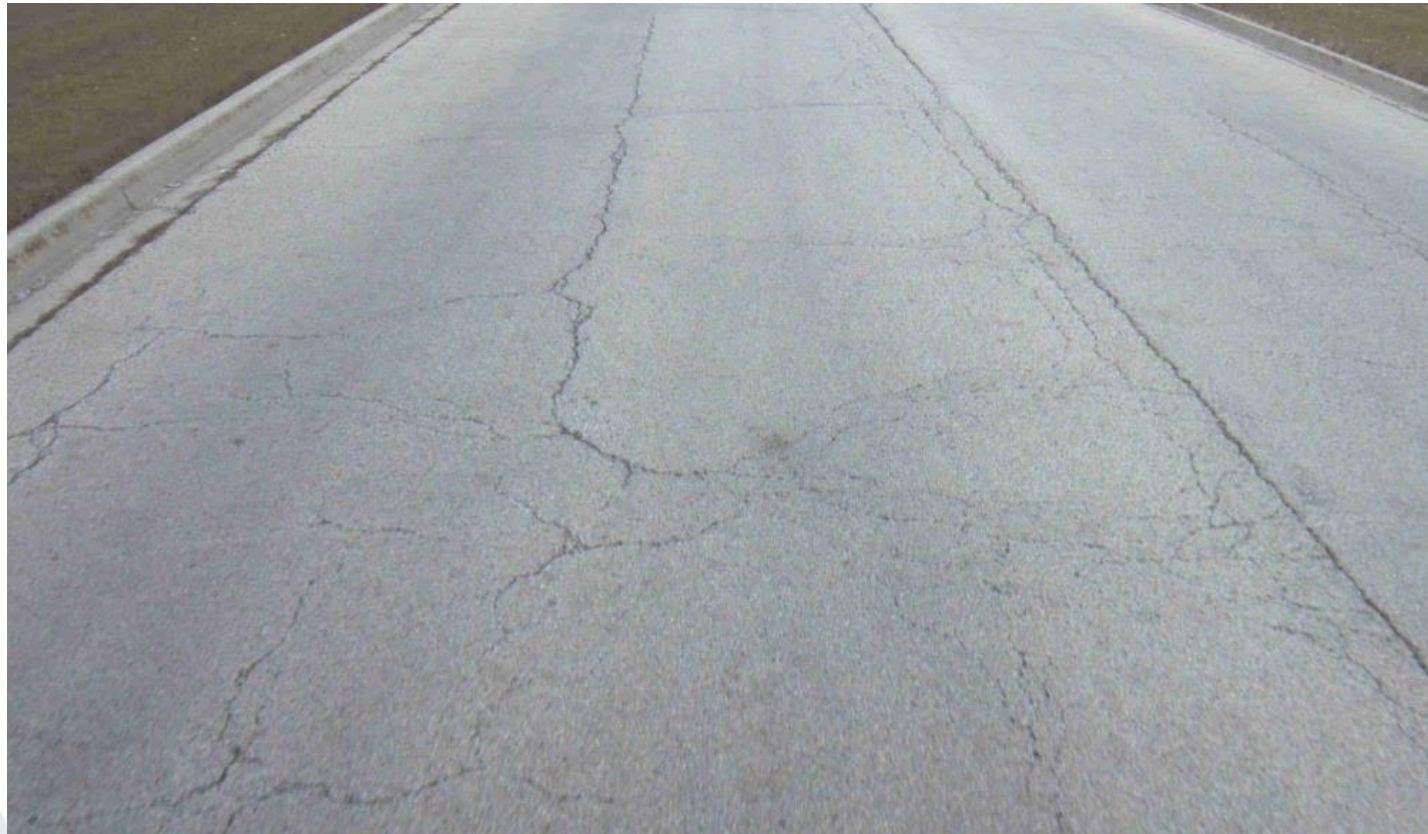
A Crk Low: 1.67 m², density: 10.7/41
A Crk Mod: 0.42 m², density: 2.71
A Crk Sev: 0 m², density: 0.0

L Crk No: 0.0 m, density: 0.0
L Crk Low: 8.58 m, density: 55.35
L Crk Mod: 0.87 m, density: 5.61
L Crk Sev: 0.0 m, density: 0.0

T Crk Low: 0.0 m, density: 0.0
T Crk Low: 15.27 m, density: 98.52
T Crk Mod: 0.4 m, density: 2.58
T Crk Sev: 0.0 m, density: 0.0

Total Crack Length: 36.81 m
Total Node Length: 25.13 m
Filtered Crack Length: 0 m
S LCrk Len: 0.96 m, density: 6.19
S ECrk Len: 0.0 m, density: 0.0
S TCrk Len: 0.0 m, density: 0.0
S ACrk Len: 0.0 m, density: 0.0

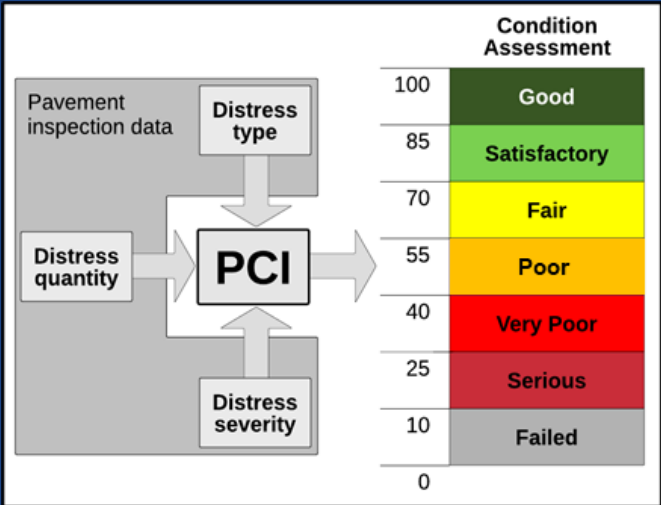
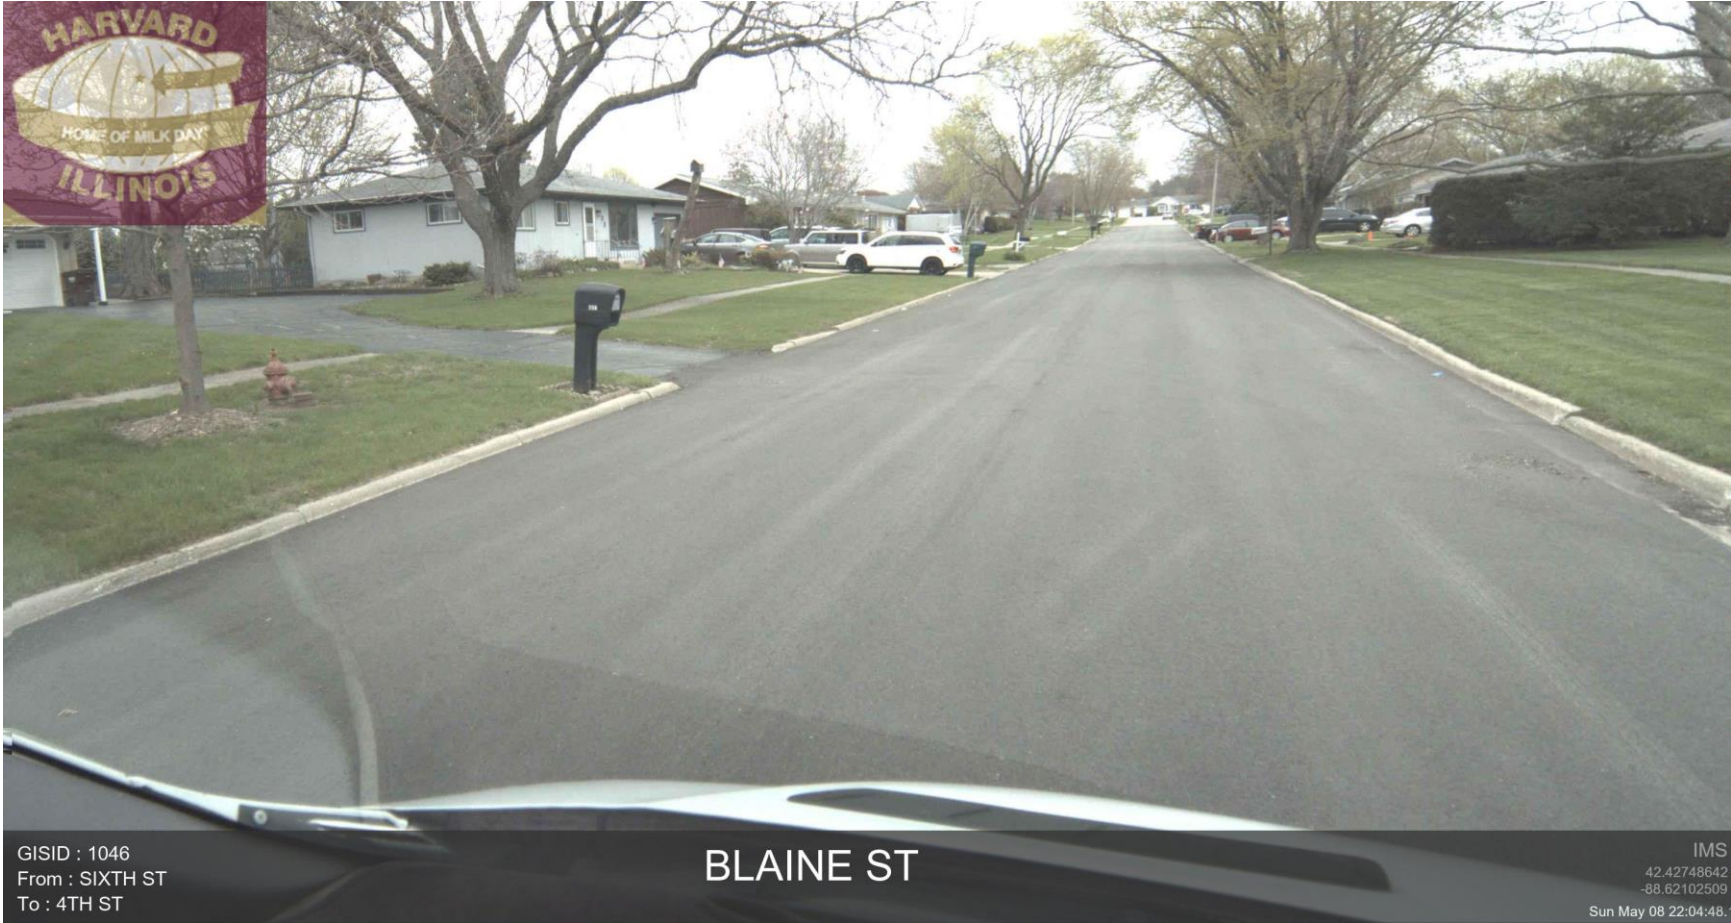
BLAINE ST

Condition = **Good (85-100)** | PCI = 100
 SIXTH ST to 4TH ST
 Distress: No Distresses
 Recommended Activity: Preventive Maintenance

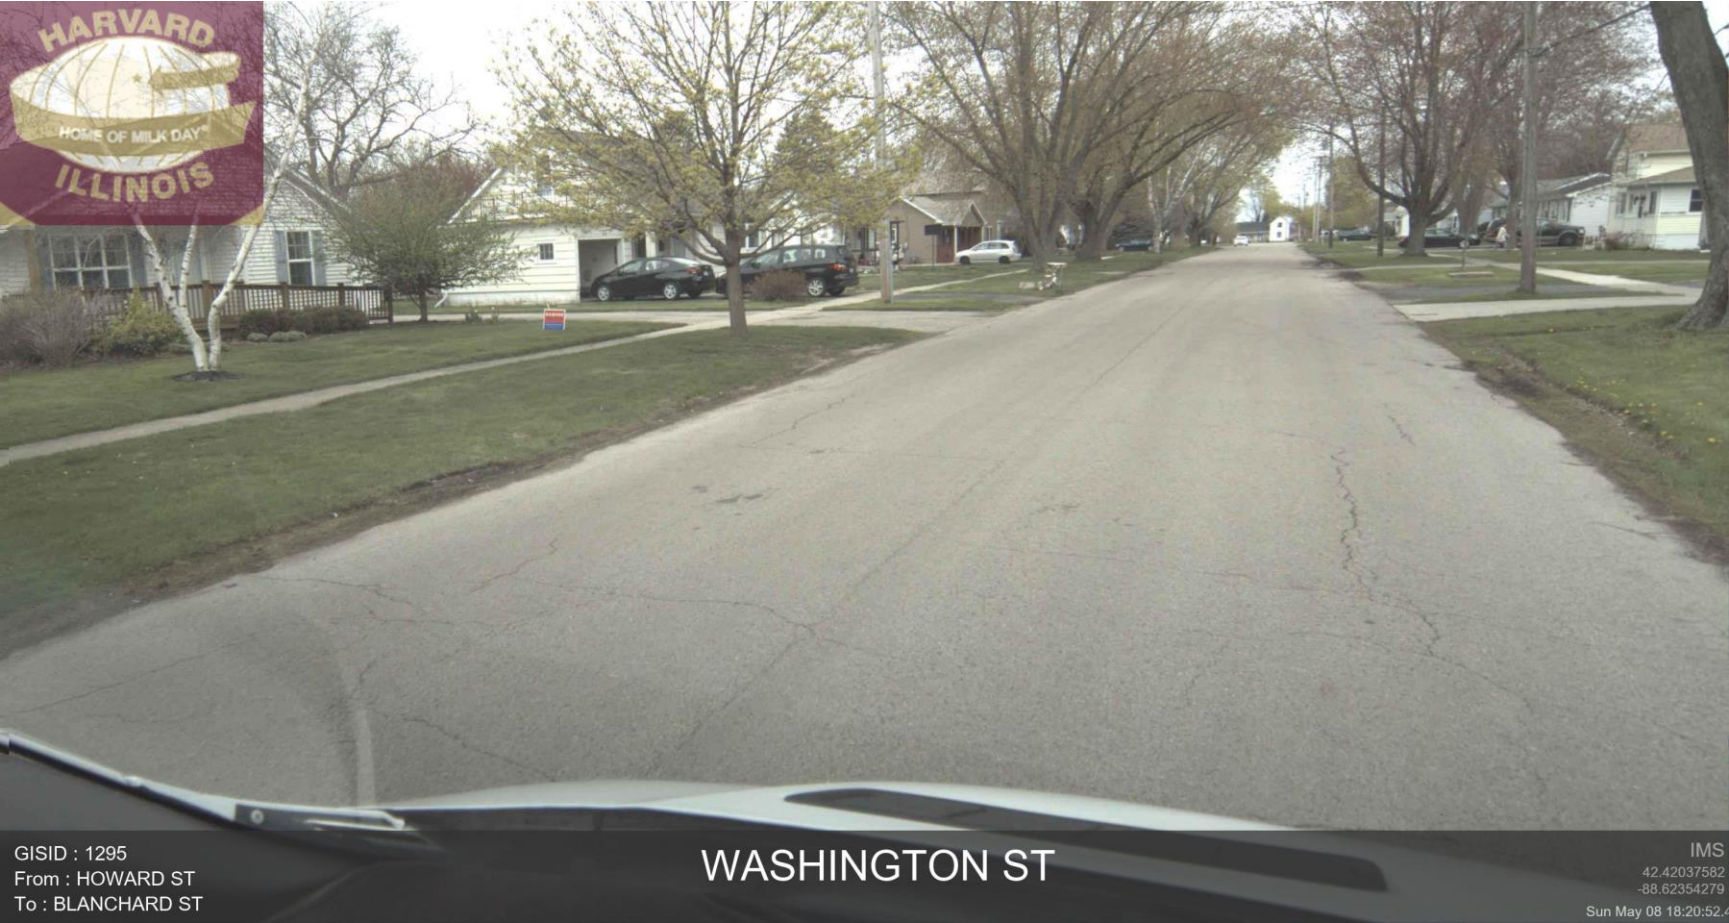
WASHINGTON ST

Condition = **Satisfactory (70-85)** | PCI = 71
 HOWARD ST to BLANCHARD ST
 Distress: Low L&T and Weathering,
 Recommended Activity: Crack Sealing and Surface Treatment

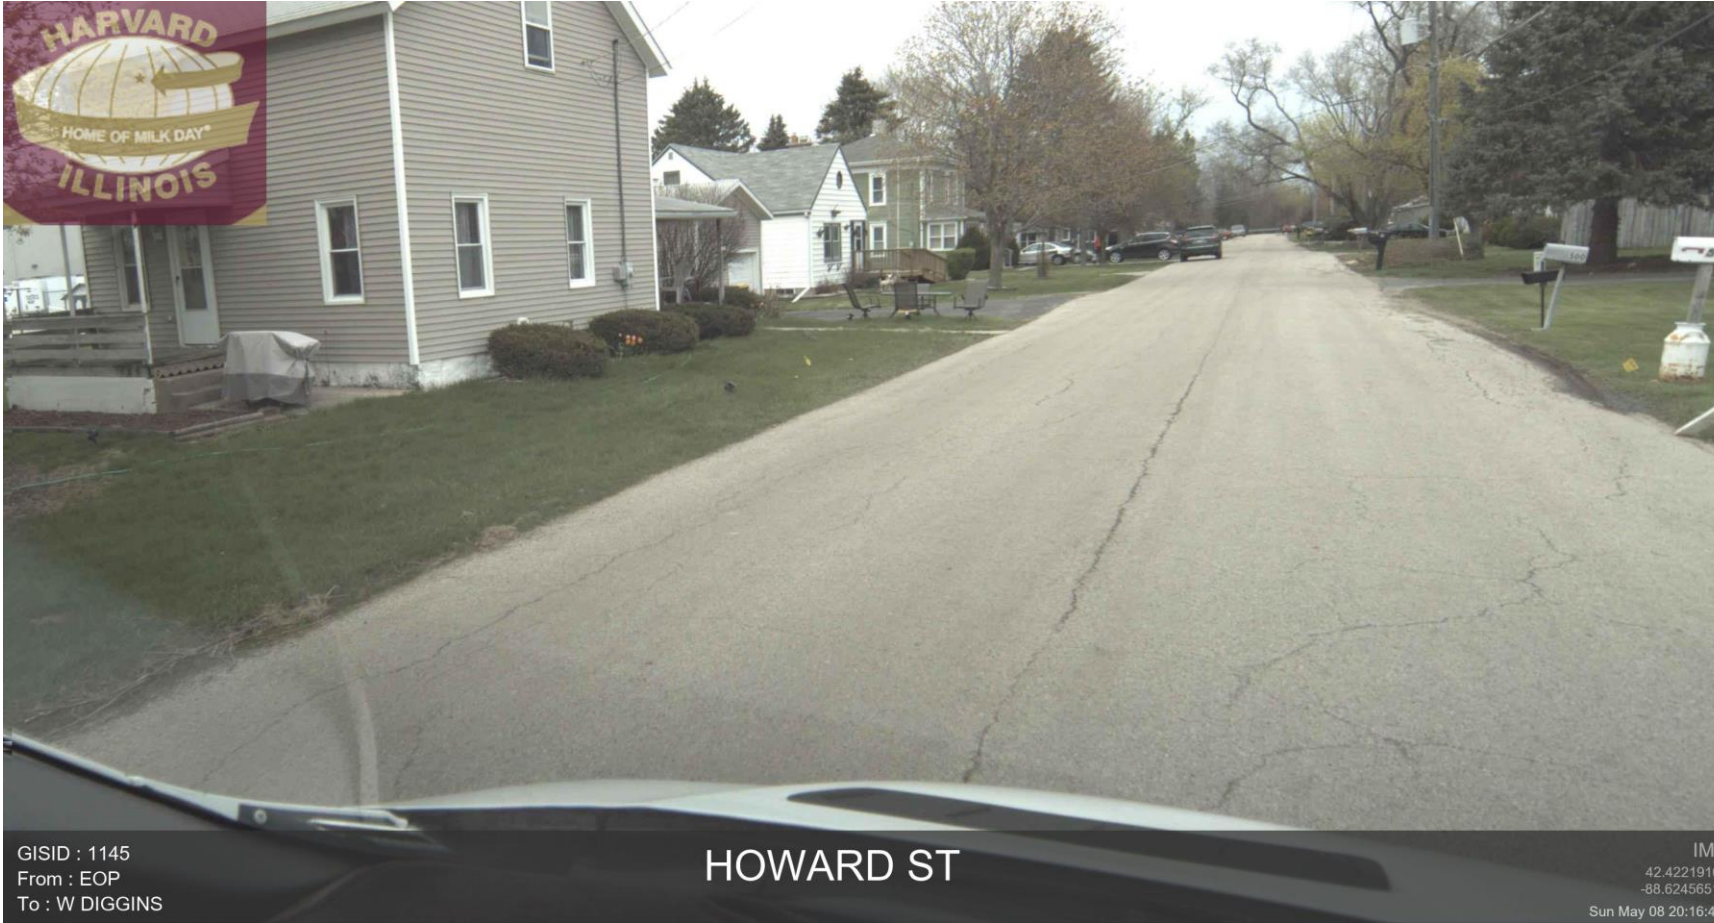
EOP to W DIGGINS

Condition = **Fair (55-70)** | PCI = 66

Distress: Low & Moderate L&T and Edge Cracking, crack seal, patching,

Recommended Activity: Thin Overlay

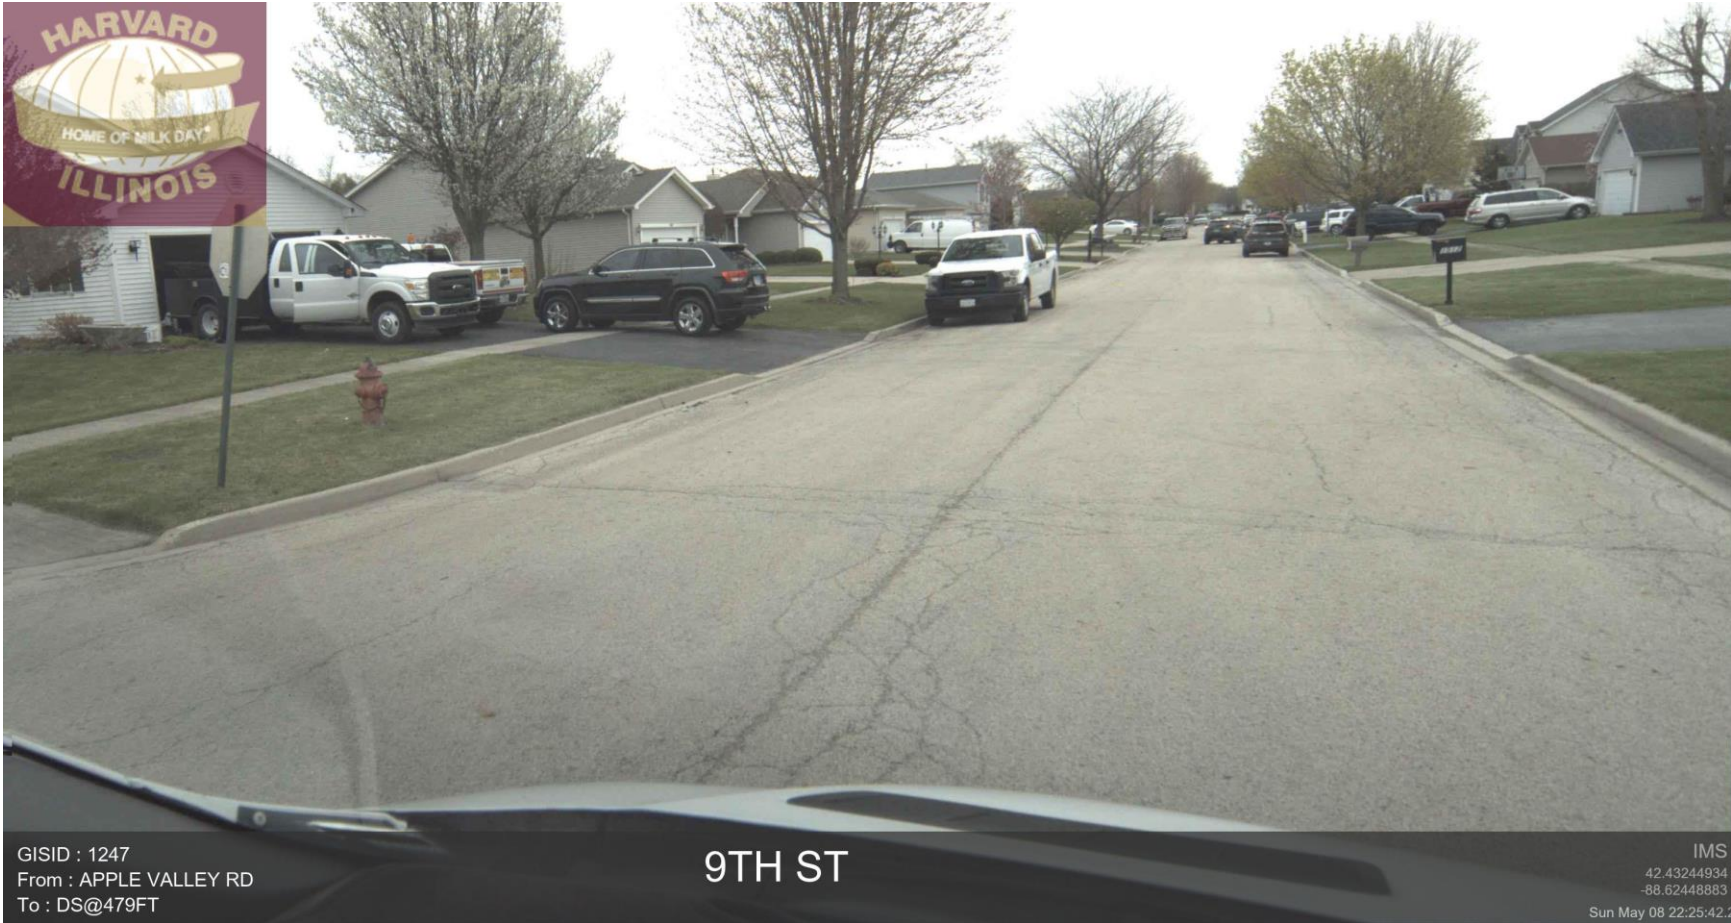
Condition = **Poor (40-55)** | PCI = 52
 APPLE VALLEY RD to DS@479FT
 Distress: L&T, Alligator, Edge Cracking
 Recommended Activity: Suitable for mill and overlay

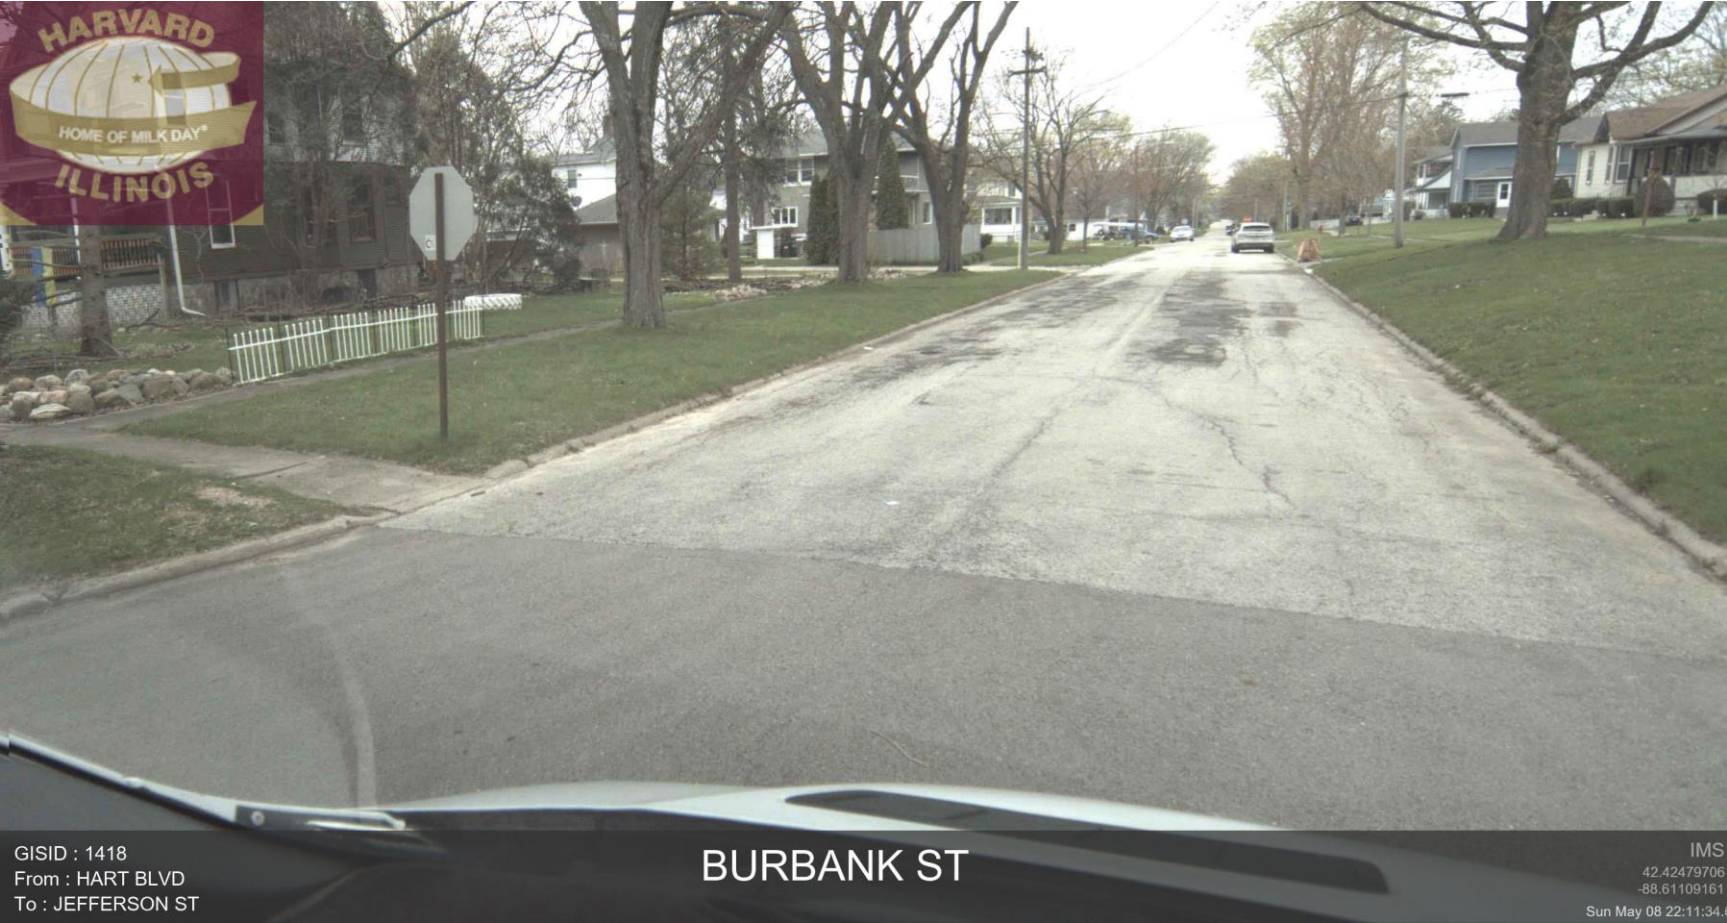
BURBANK ST

Condition = **Very Poor (25-40)** | PCI = 31

Distress: Alligator cracking, Edge Cracking, Raveling

Activity: Thick overlay with extensive patching / Surface Reconstruction

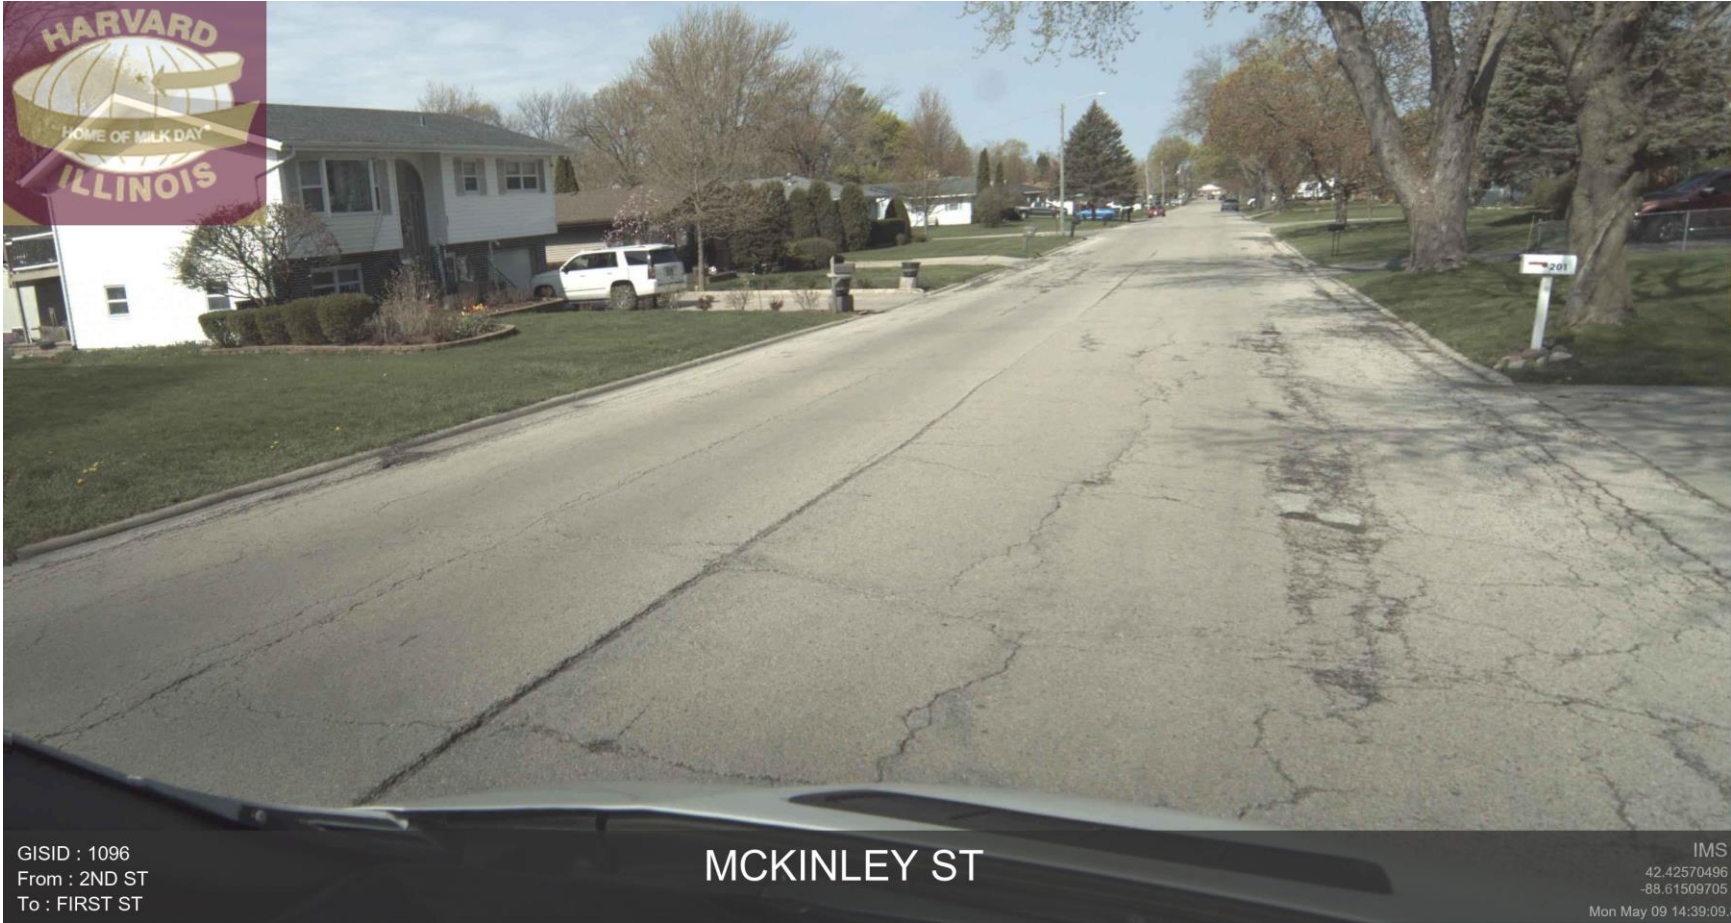
MCKINLEY ST

Condition = **Serious (10-25)** | PCI = 21

Distress: Severe Alligator cracking, Edge Cracking, potholes

Activity: Surface Reconstruction with Base Repairs

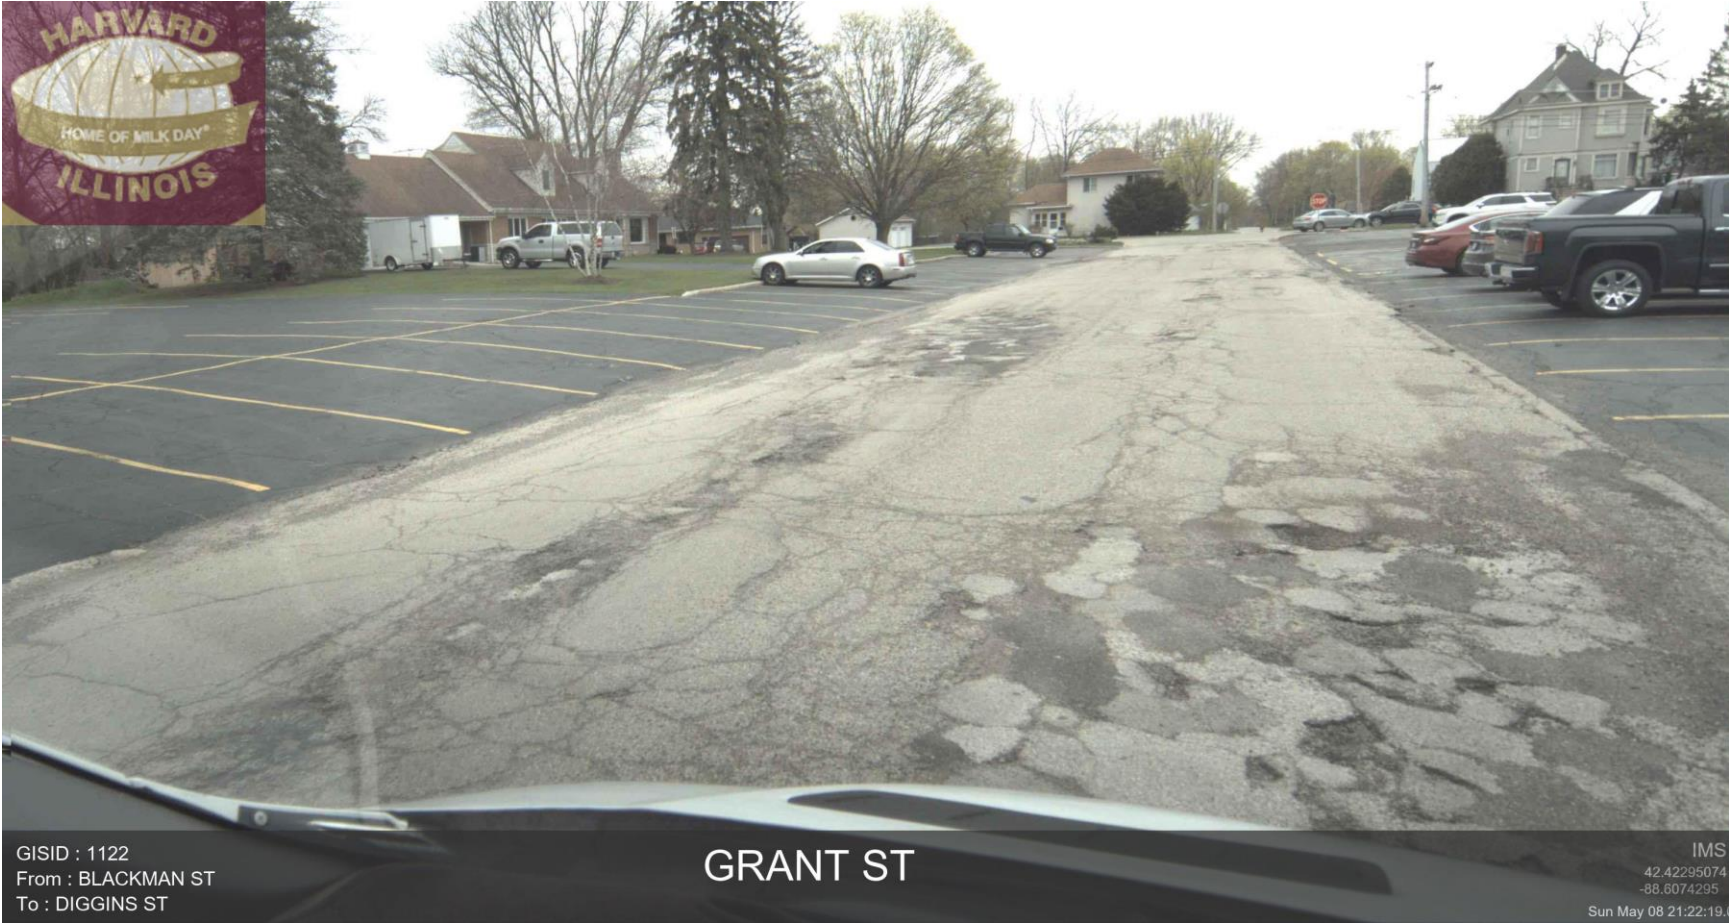
Condition = **Failed (0-10)** | PCI = 9
 BLACKMAN ST to DIGGINS ST
 Distress: Severe Alligator cracking and potholes
 Activity: Full Reconstruction

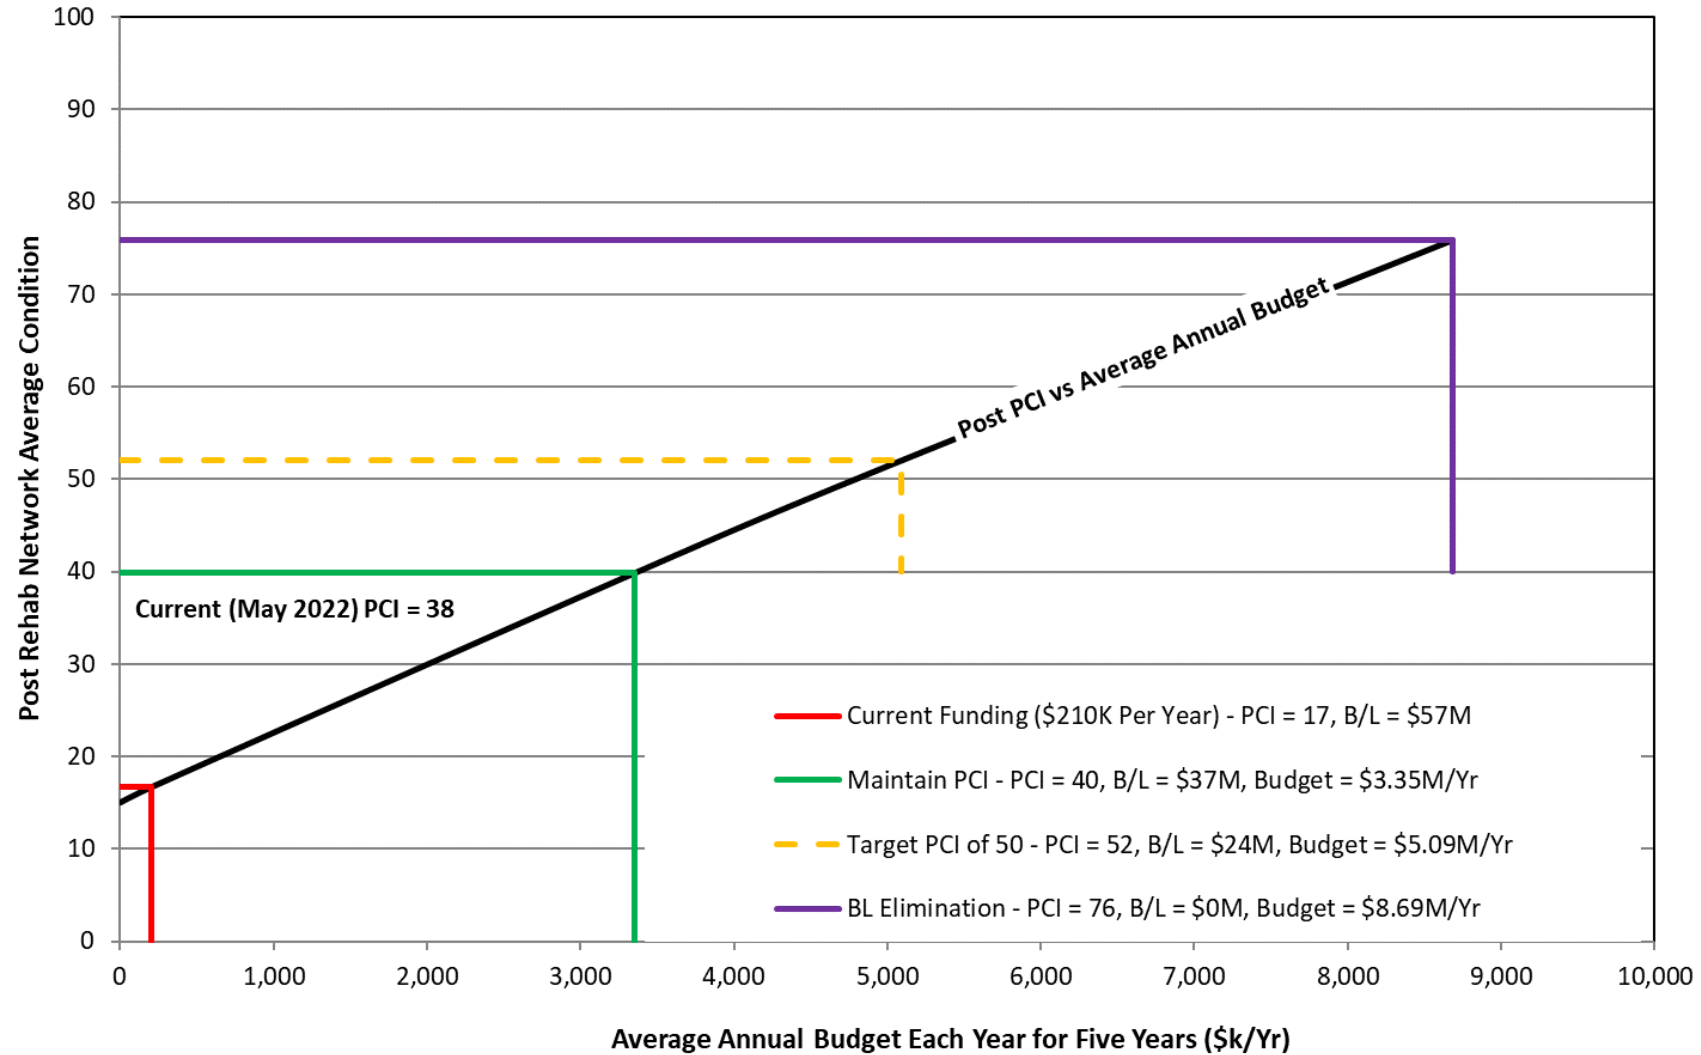
Harvard, IL Five Year Post Rehab PCI Versus Annual Budget

Scenario Description	Annual Budget (\$/Yr)	5 Year Total Spending (\$/Yr)	Remaining B/L (\$Yr)	Total Cost (Spending + B/L) (\$k)	PCI at the End of Analysis
Do Nothing	\$0	\$0	\$58M	\$58M	15
Current Funding (\$210K Per Year)	\$210k	\$1M	\$57M	\$58M	17
Maintain Current PCI	\$3.3M	\$16M	\$37M	\$54M	40
Target PCI of 50	\$5.1M	\$25M	\$24M	\$49M	52
BL Elimination in 5 years	\$8.7M	\$43M	\$0	\$43M	76
