**SUBJECT:** **Harvard STP (McHenry County)**  
NPDES No. IL0020117  
BOW ID No. W1110250005

## INSPECTION REPORT

Facility Name:	Harvard WWTP (McHenry County)
NPDES Permit No.:	IL0020117
BOW ID No.:	W1110250005
Basin Code:	PQEA-111
Inspection Type:	Compliance Evaluation
Date of Inspection:	June 1, 2018
Inspected By:	Karen Katamay, EPE III/CPESC
Interviewed:	Jim Grant, Superintendent

Harvard WWTP CEI  
 Inspection Date: June 1, 2018

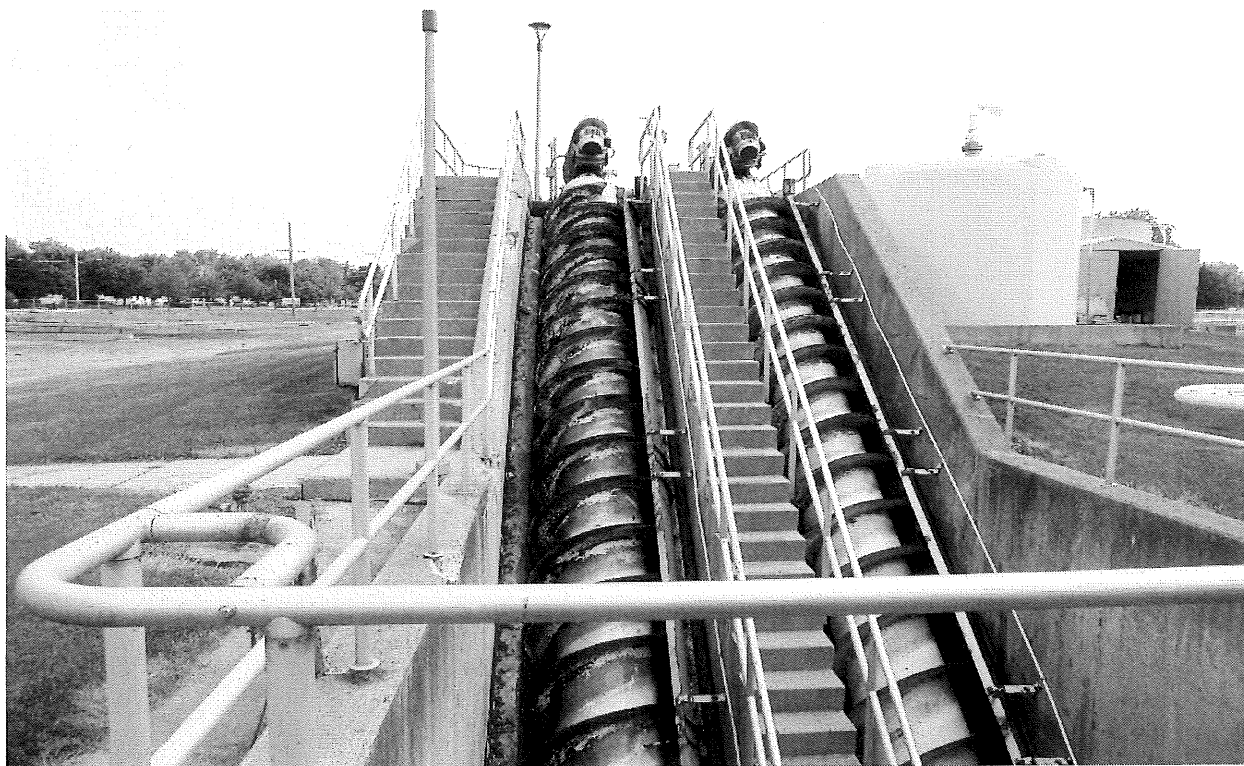
Flow passes through a raw sewage pumping station consisting of two screw pumps, each rated at 3.75 MGD. Usually only one is used at a time. Influent passes through an auger following the pumping station.

Photo 1 – Influent screw pumps

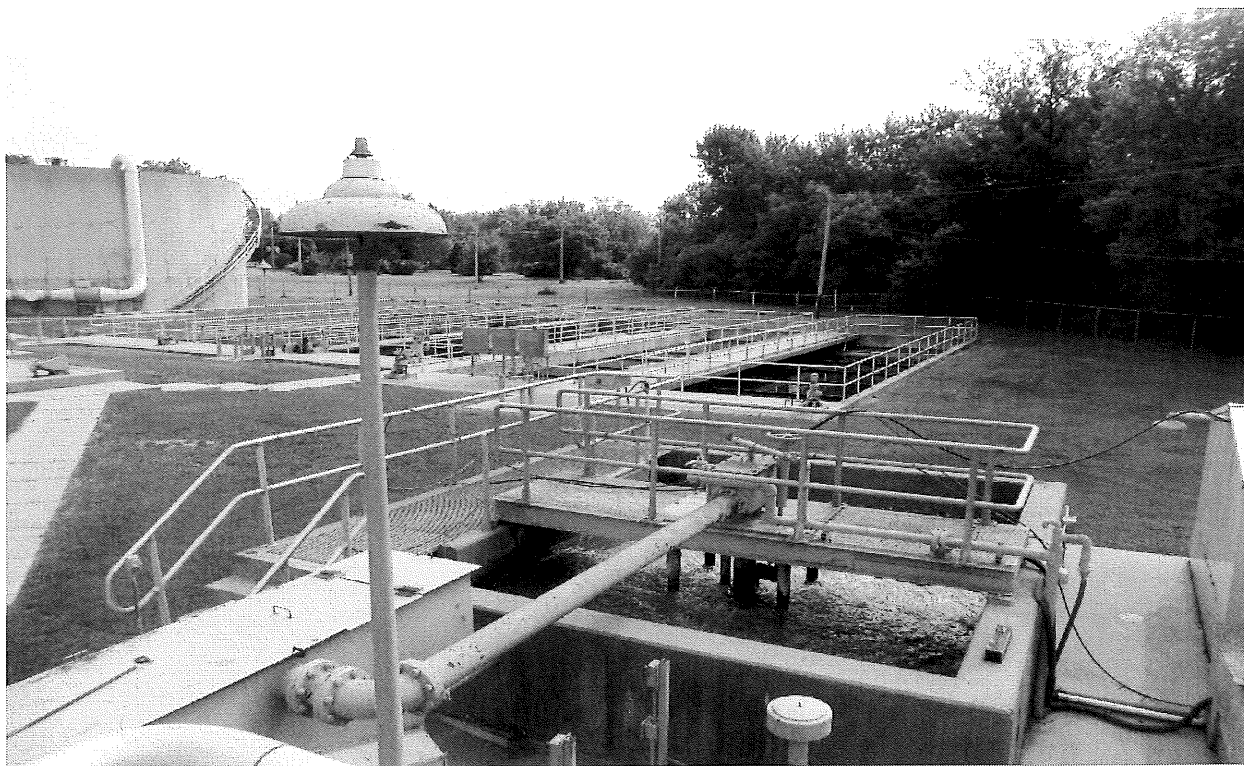
An aerated grit tank (12' by 12' by 15' SWD, 10,000-gallon capacity) is provided for grit removal. Grit is removed from the bottom of the tank by air lift to a grit washer and separator. Grit is then put in a dumpster and landfilled. The unit appeared to be operating satisfactorily at the time of the inspection.

Photo 3 – Aerated grit tank

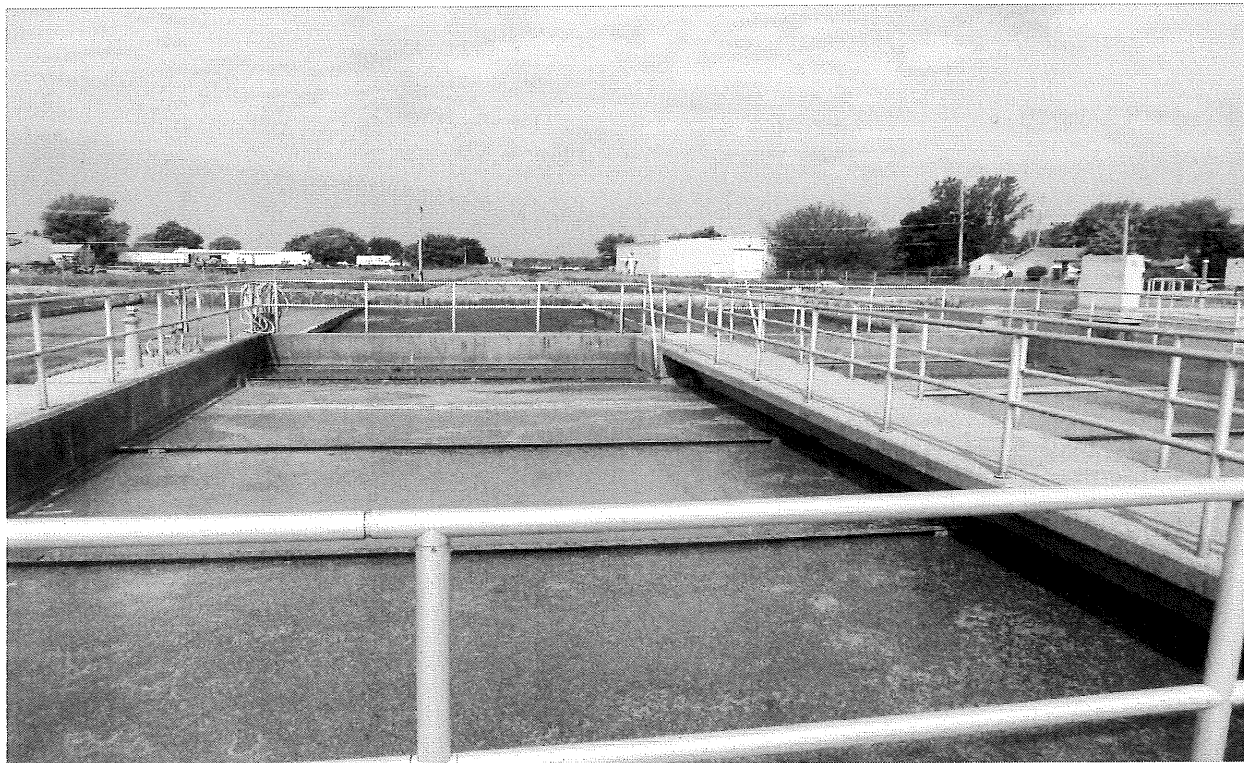
The primary clarifiers have a surface settling rate of 900 gpd/sq.ft. at DAF and 2250 gpd/sq. ft. at DMF. The Illinois recommended standard maximum loading rate for primary clarifiers is 1000

gpd/sq.ft. at peak flow. At the time of the inspection, the primary clarifiers were showing significant scum and foam.

Photo 5 – Primary clarifiers showing foam and scum

The primary clarifiers currently have surface settling rates of 900 gpd/sq.ft. at DAF and 2250 gpd/sq.ft. at DMF. The loading at DMF exceeds the recommended design standard of 1000 gpd/sq.ft. Additional primary treatment capacity would also aid the facility by reducing loading to their packed bed filter.

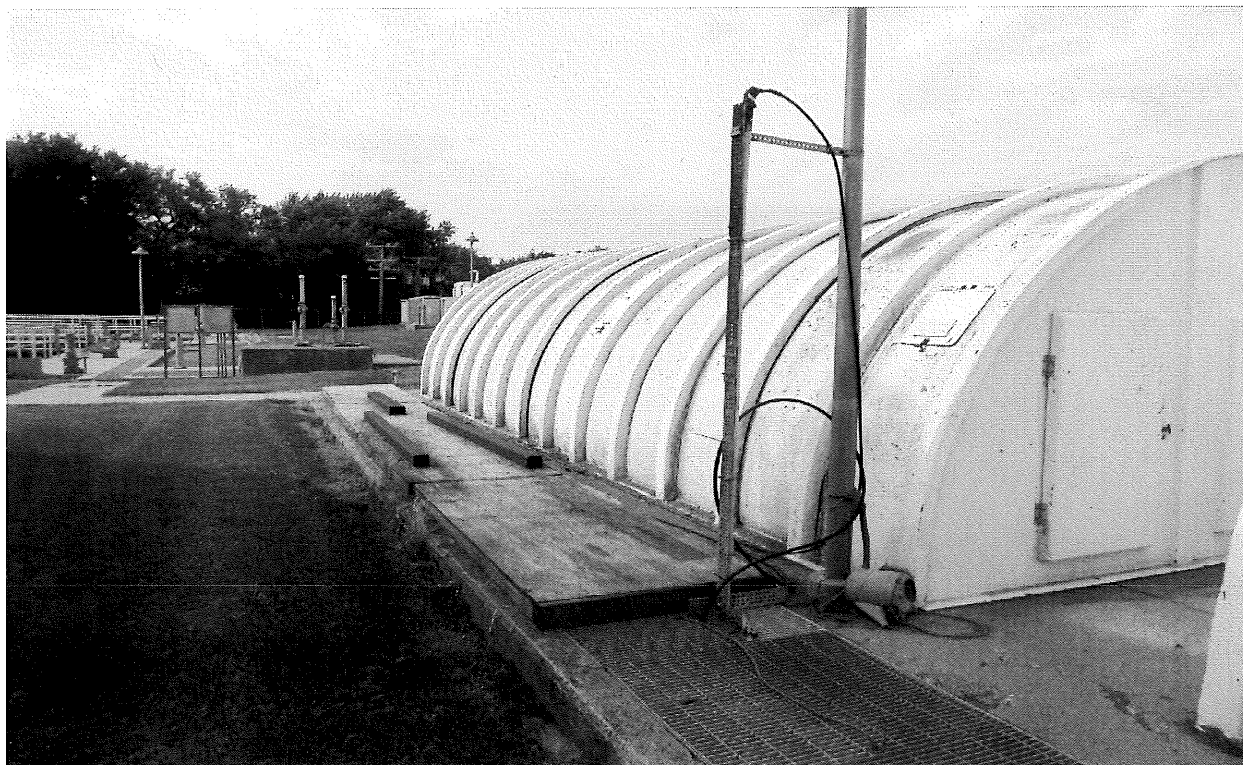
Photo 7 – The outside of one of the RBCs and feed location for the polymer

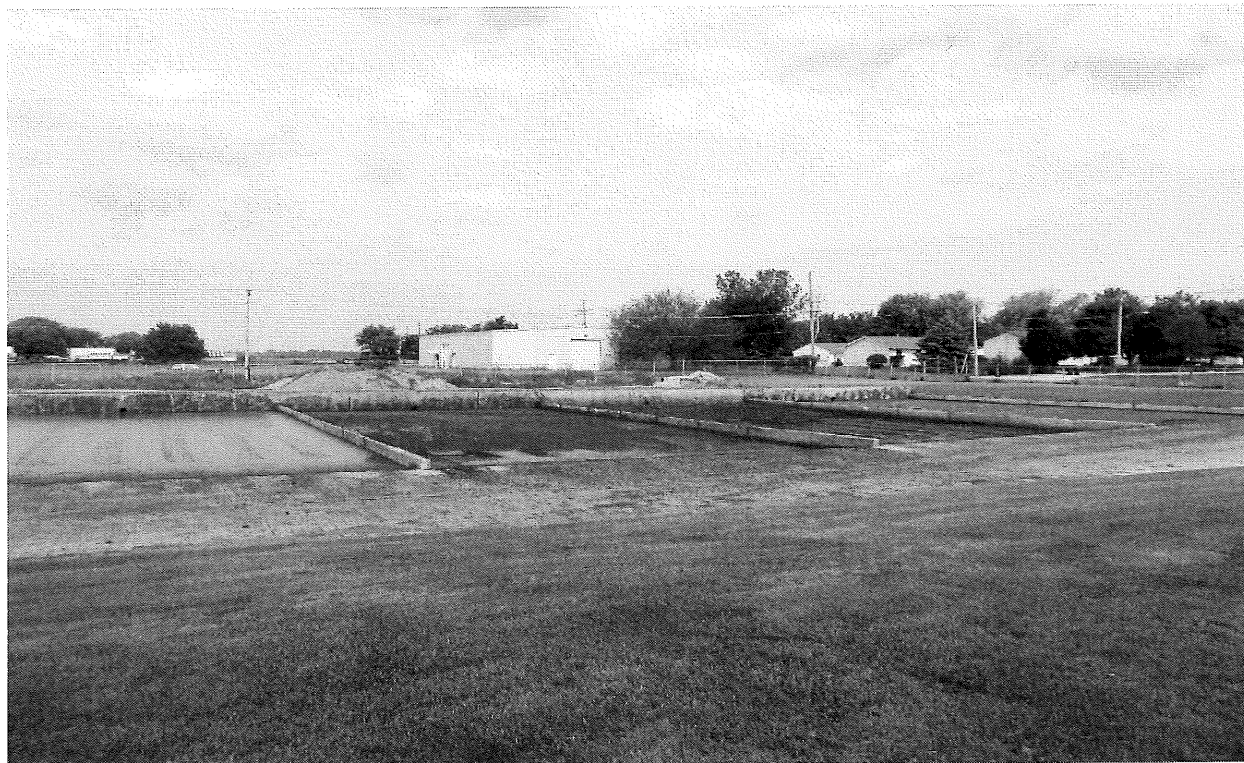
Photo 10 – Some of the sludge drying beds

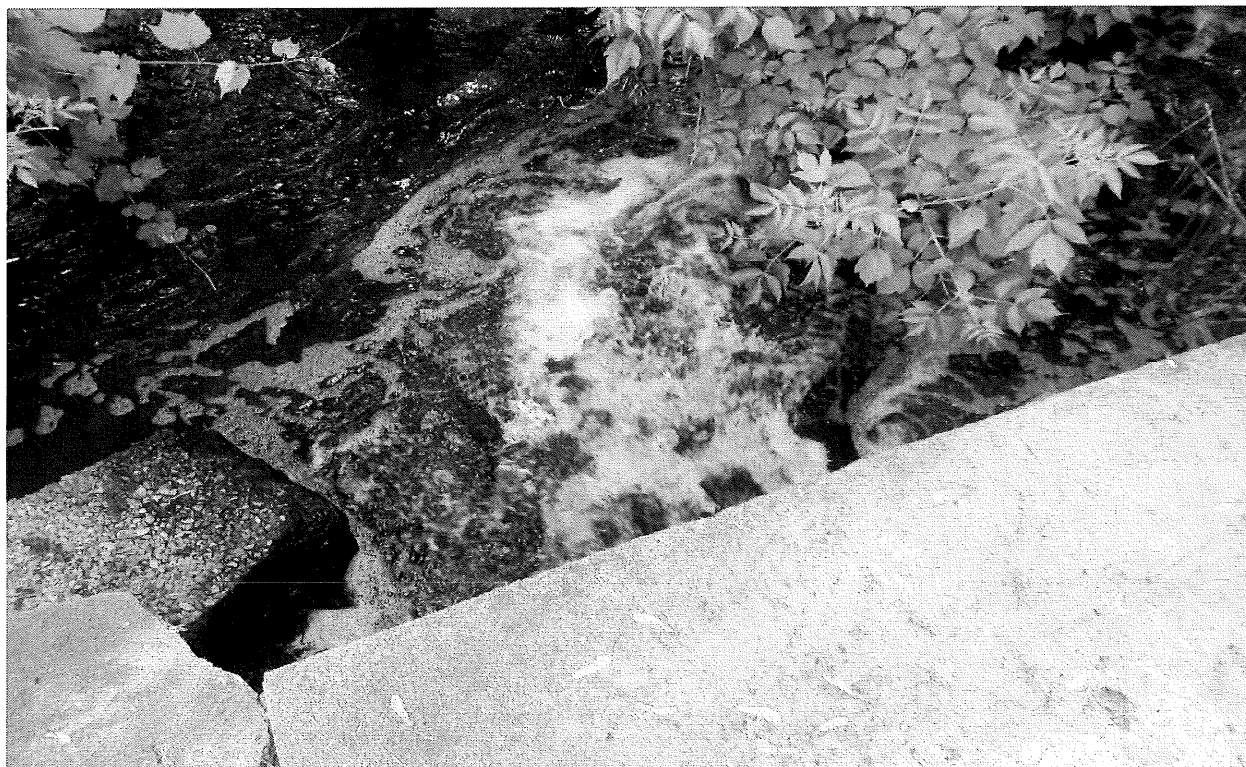
Photo 14 – Effluent outfall to creek

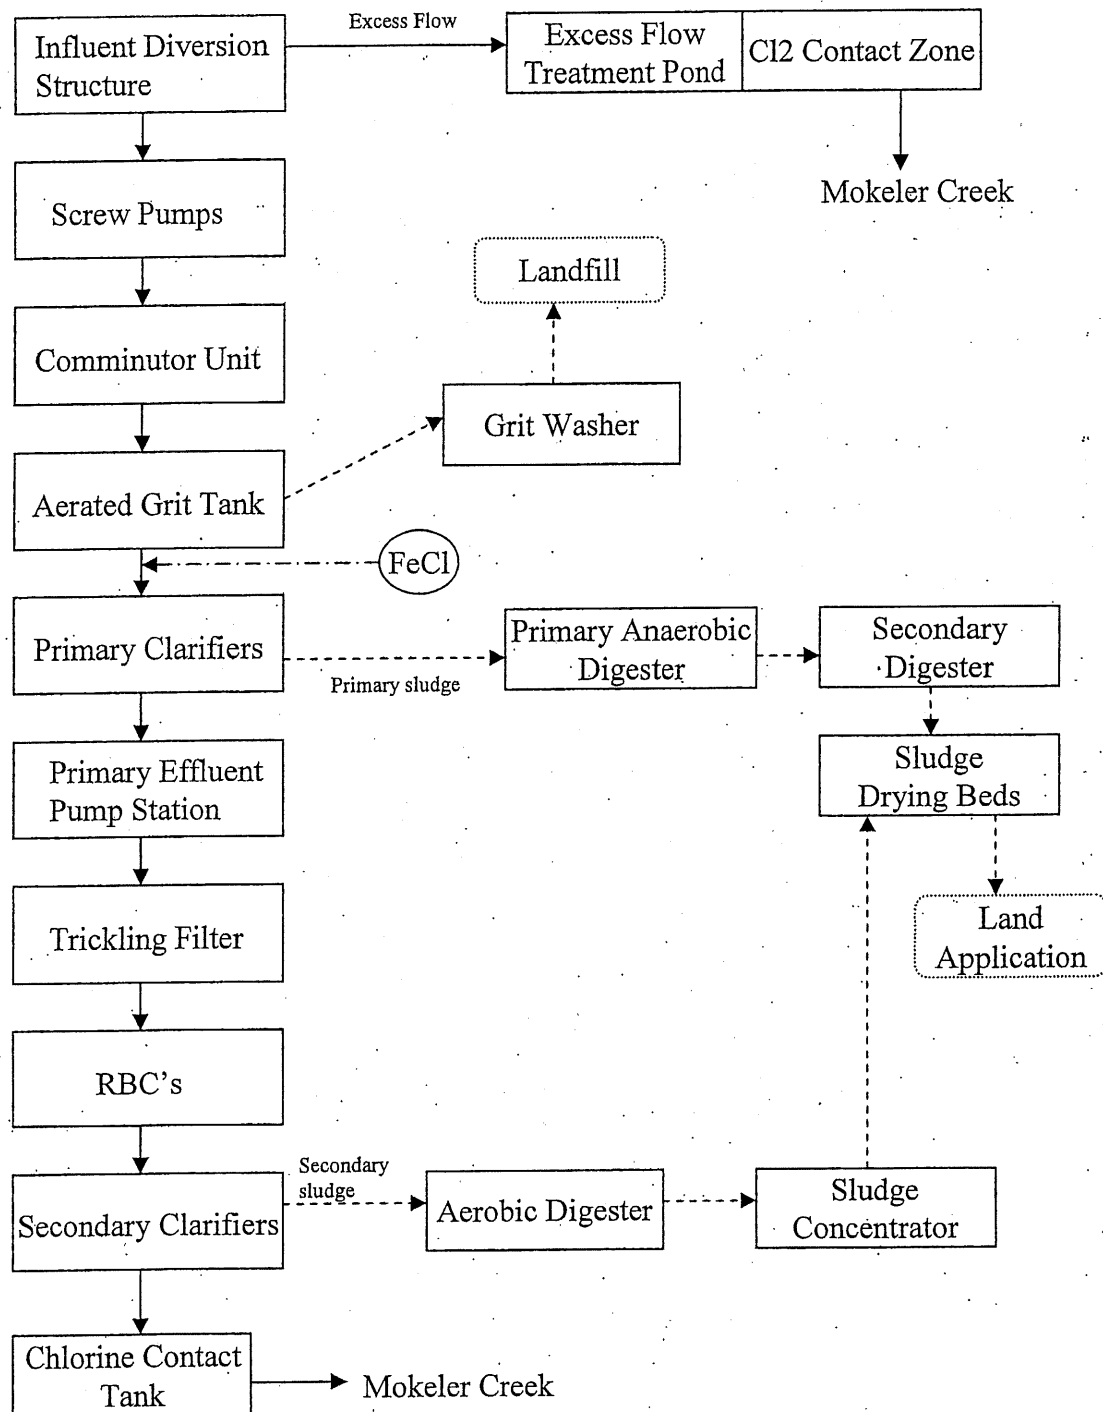
ATTACHMENT A

Attached is a current flow diagram of the facility (Attachment A). Also attached are some photos taken on the day of the inspection.

City of Harvard STP
